# Manhole Inspection Summary

Manhole # S13II\_036MH

Insp Date: **2/24/09 9:38 AM**

**Location** Address: **REAR ASHBURTON ST**

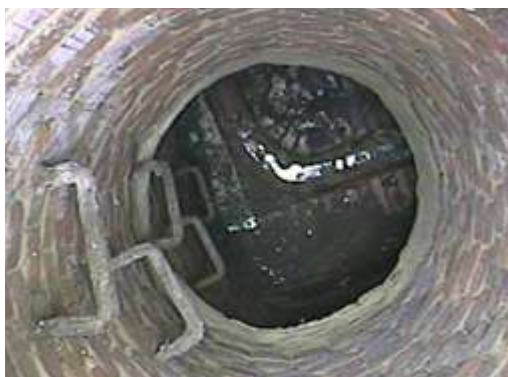
Defect 1

**Steps** Count: **7** Missing: **0** ☒ **Corroded**

CORRODED STEPS

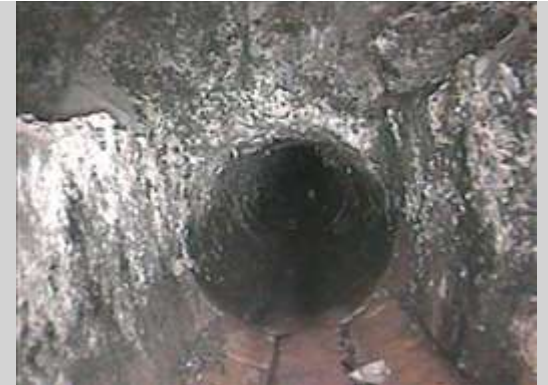
12 O'Clock Outflow

8 in. Circular Gravity Sewer  
Pipe Out @ 12 O'Clock

Pipe Height: (in.) Direct  
Pipe Material: **Clay** ☐ Pipe Lined  
Invert Depth: **11.49** (ft.) Flow Characteristics: **Slow**  
Deposits: ☒ None ☐ Mud ☐ Sludge ☐ Debris ☐ Grease  
Silt Depth: (in.) Deposits Extent:  
Infiltration: **None** Pipe Seal Cond: **Sound**

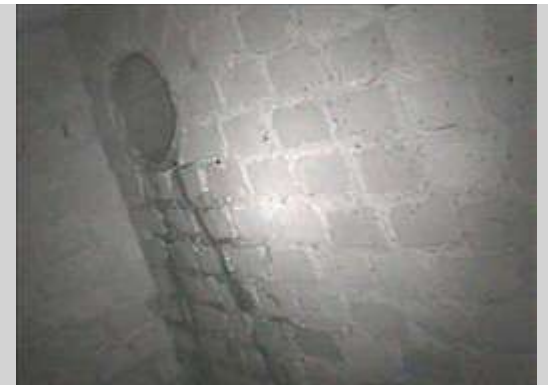
9 O'Clock Inflow

8 in. Circular Gravity Sewer  
Pipe In @ 9 O'Clock

Pipe Height: (in.) Direct  
Pipe Material: **Clay** ☐ Pipe Lined  
Invert Depth: **9.17** (ft.) Flow Characteristics: **Slow**  
Deposits: ☒ None ☐ Mud ☐ Sludge ☐ Debris ☐ Grease  
Silt Depth: (in.) Deposits Extent:  
Infiltration: **None** Pipe Seal Cond: **Sound**

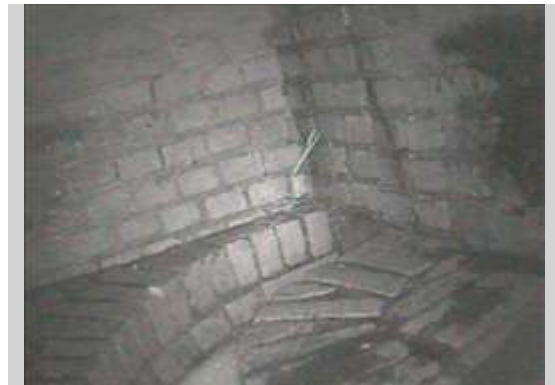
Drop In @ 9 O'Clock

Drop: **Outside Direct**

Inv Depth: **11.42** (ft.)

Drop Condition: **Open**
